FTMCTRL/MCTRL/SDCTRL: SDRAM Initialization Errata

Technical note

Doc. No GRLIB-TN-0020

Issue 1.1

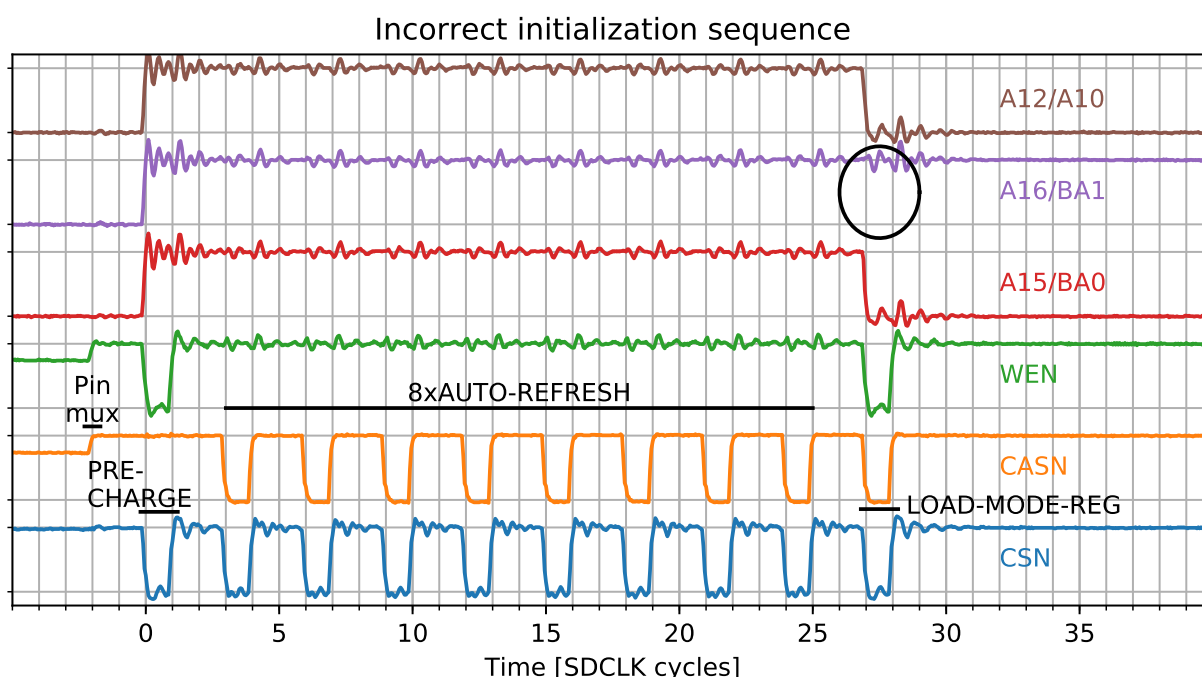
When the errata occurs, the SDRAM memory component will not be initialized with the configuration parameters set in the memory controller. This may lead to a mismatch of settings for parameters such as CAS latency and burst length. Figure 2 below shows an example of an incorrect SDRAM initialization sequence being issued from a GR712RC component.

Figure 2: Example oscilloscope measurement of an SDRAM initialization sequence where the issue resulted in the final LOAD-MODE-REG command being incorrect. The traces were recorded on a GR712RC-BOARD.

Specifically, Figure 2 shows oscilloscope traces from a GR712RC where the issue resulted in an incorrect SDRAM initialization sequence. The SDRAM controller is enabled at $t = -2$. This can be seen as a small edge on the WEN and CASN pins (these pins are multiplexed in the GR712RC and enabling the SDRAM controller changes the mux setting). Then the initialization sequence begins at $t = 0$ with a PRECHARGE command, followed by 8 AUTO-REFRESH commands and concluding with what should have been a LOAD-MODE-REG command at $t = 27$. However the issue described in this document caused BA1 to remain at 1 so this is not a valid LOAD-MODE-REG command. External SDRAM memory devices that implement an “extended mode register” in addition to the regular “mode register” would interpret this as a LOAD-EXT-MODE-REG command.

A correct SDRAM initialization sequence can be attained by initializing the internal memory controller register that drives the address pin corresponding to SDRAM bank address 1 (BA1, address bit 16). The following sequence will initialize this register and initialize the SDRAM with the values configured in the memory controller register interface:

1. Enable the SDRAM controller.¹
2. Wait for the SDRAM initialization sequence to complete.
3. Write any value to the first SDRAM address.
4. Disable the SDRAM controller.
5. Re-enable the SDRAM controller.

This sequence (specifically step 3) guarantees that address bit 16 is 0 during the LOAD-MODE-REG command executed in step 5.

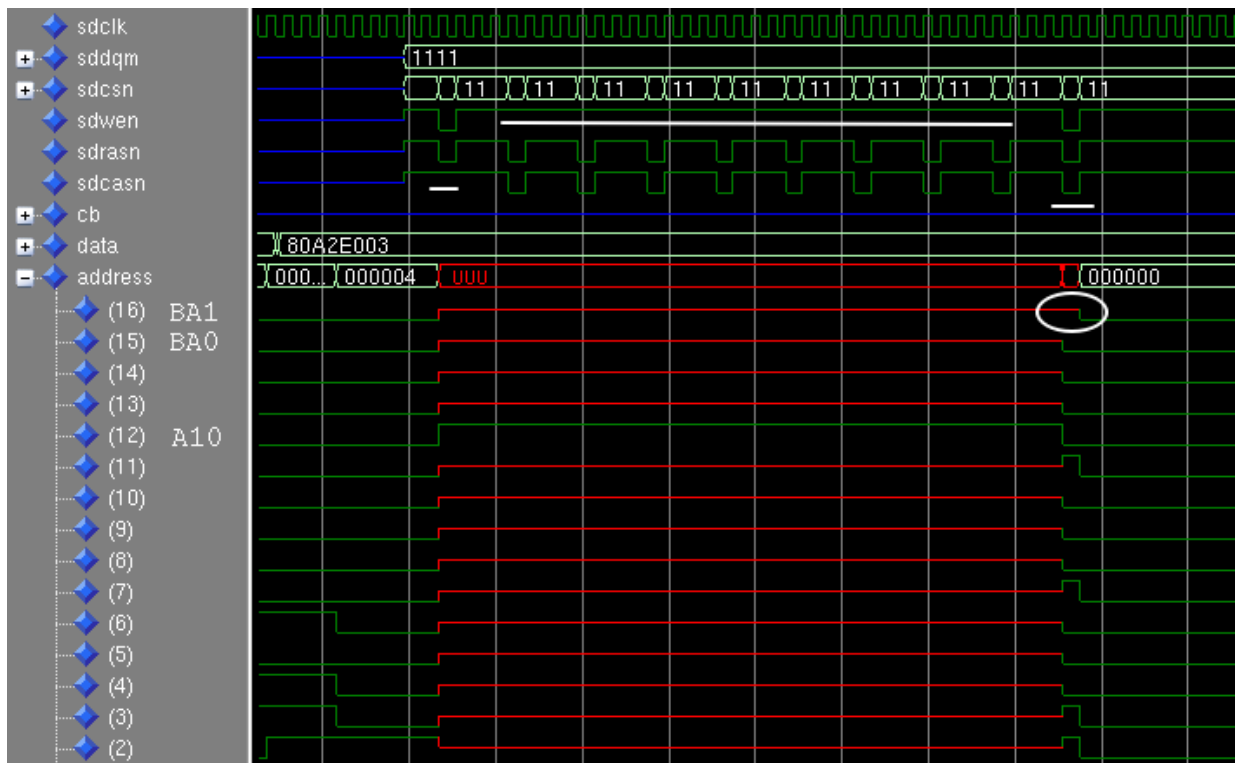
The SDRAM controllers affected by this issue contain an internal register that drives the address bus during SDRAM operations. However, due to a design error, bit 16 of this register is not updated during execution of a LOAD-MODE-REG command, but instead retains its previous value. Additionally this internal address register is not affected by reset and therefore contains undefined values after power-up. This is illustrated in Figure 3 that shows the state of the SDRAM memory bus in an RTL simulation of an affected memory controller. Undefined values (U) are shown in red.

The issue was not detected during memory controller IP core verification due to the SDRAM simulation models used not caring about the uninitialized register value.

The issue was not detected during FPGA verification due to the register being initialized to zero in FPGA prototypes.

Figure 3: RTL simulated view of the external memory bus of an affected SDRAM controller during the first initialization sequence after simulation start (equivalent to power-up). Compare Figure 2.
