FTMCTRL/MCTRL/SDCTRL: SDRAM Initialization Errata

Technical note

Doc. No GRLIB-TN-0020

Issue 1.1

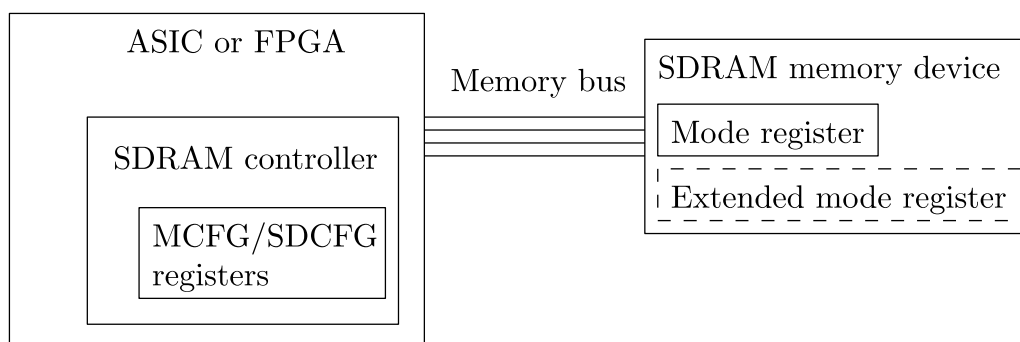
The command in the sequence above (LOAD-MODE-REG) is used to set programmable parameters in the mode register of the SDRAM memory device. The contents of this register must be consistent with the configuration of the SDRAM memory controller. Notably, these programmable parameters include CAS latency and burst length. Figure 1 contains a block diagram showing the location of registers whose values need to be compatible for correct SDRAM operation.

Figure 1: Simplified overview of a system that could be affected by the errata. Note that not all SDRAM memory devices implement an extended mode register.
